Fire Risk Assessment

Address: 14 Slatey Road
Birkenhead
Wirral
Merseyside
CH43 1US

Assessor: Mr. T Graham BSc (Hons) Fire Safety

Date: 13th May 2019

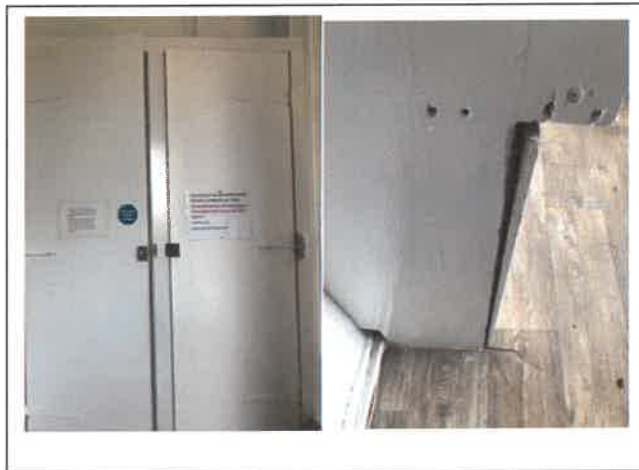
Fig 1: Non fire rated electrical cupboard (non fire rated hinges and only partial upgrade of cupboard)

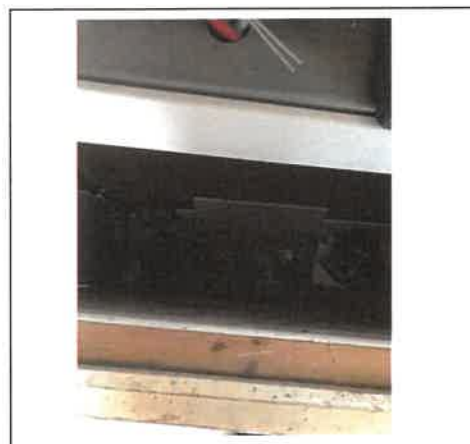
Fig 2: Small amount of waste items in base of electrical intake cupboard

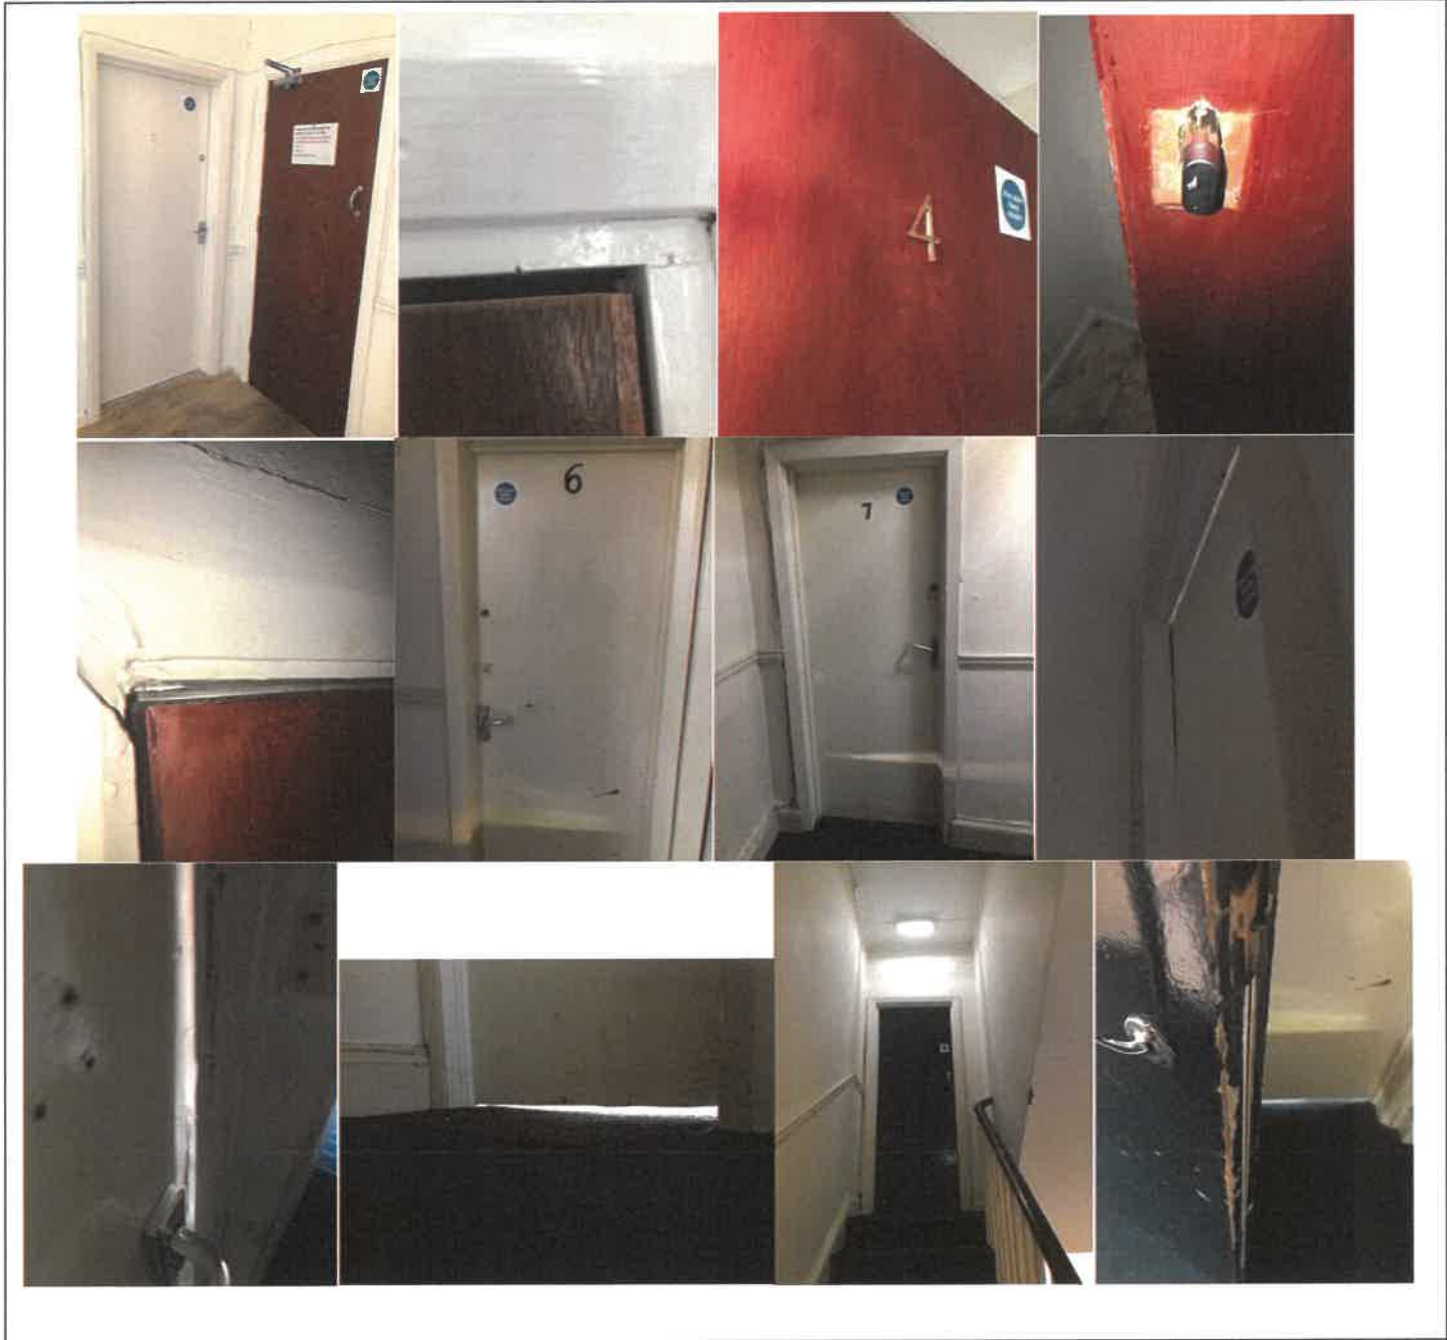
Fig 3: Unverified repairs to flat entrance and second floor lobby doors where new locks have been fitted which in turn has compromised the integrity of the doors. Furthermore, number of flat entrance doors, most notably Flats 6, 7 & 8 on the second floor were in a state of disrepair with large gaps from the door to the frames and at the base of the door to the floor being noted - recommended replacement of flat entrance doors with modern FD30s door sets

<p>8) PASSIVE FIRE PROTECTION (PFP) – COMPARTMENTATION</p>	<p>Due to the building being a converted building comprehensive levels of compartmentation cannot be guaranteed.</p> <p>Flats 3, 4 and 5 all appear to be replacement doors which are of a more modern standard than those fitted to flats 2, 6, 7 & 8. However, from a sample inspection of flat 4 there were no identification stickers or plugs on the door to confirm their fire rating. Furthermore, due to the lack of fire rated hinges fitted to Flat 4 and the gaps around the deadlock from an unverified repair the doors cannot be confirmed as being able to provide the required thirty minutes fire resistance, even on a notional basis - see action plan.</p> <p>However, the ground floor entrance lobby door is a new replacement FD30s door set.</p> <p>It was reported by the client that they have taken steps to implement systematic fire door checks with formal inspection worksheets to ensure all fire doors are maintained in good condition.</p>	<p>The second floor lobby door frame is incorrectly fitted and does not sit flush up against the wall.</p> <p>Flats 3, 4 and 5 all appear to be replacement doors which are of a more modern standard than those fitted to flats 2, 6, 7 & 8. However, from a sample inspection of flat 4 there were no identification stickers or plugs on the door to confirm their fire rating. Furthermore, due to the lack of fire rated hinges fitted to Flat 4 and the gaps around the door and deadlock from an unverified repair the doors cannot be confirmed as being able to provide the required thirty minutes fire resistance, even on a notional basis.</p> <p>Entrance doors to flats 6, 7 and 8 were in a state of disrepair with no amount of repairs being possible to bring the doors back up to a suitable standard. These doors were seen to have large gaps around the doors, were not closing flush against the frame or in the case of Flat 8 were seen to have become twisted.</p>	<p>Ensure the second floor lobby door frame is re-set by a competent person so it sits flush with the wall.</p> <p>Ensure entrance doors to flats 2-8 are replaced with modern FD30s door sets.</p> <p>Priority for these works should start with the entrance doors for flats 6, 7 & 8 which were in particular poor condition at the time of inspection.</p> <p>Note - All certification for the doors and identifying stickers on the doors should be kept as proof of their fire resistance rating.</p> <p>All flat entrance doors must be self-closing, fitted with three fire rated hinges, smoke seals / intumescent strips and must not have any gaps in excess of 3mm from the door to the frame.</p> <p>Furthermore, all doors sets should only be installed by competent persons.</p>

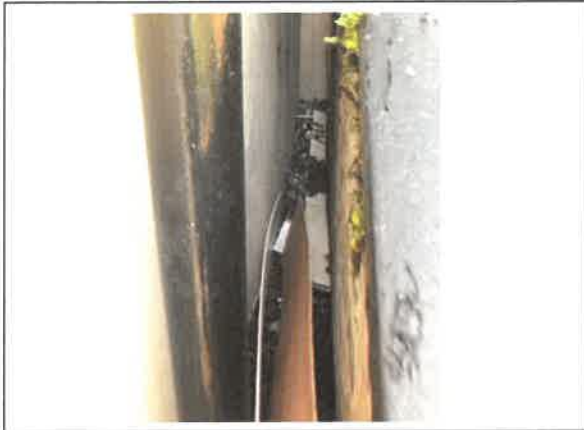
Fig 4: Build up of combustibles to side of external concrete staircase to main entrance door.

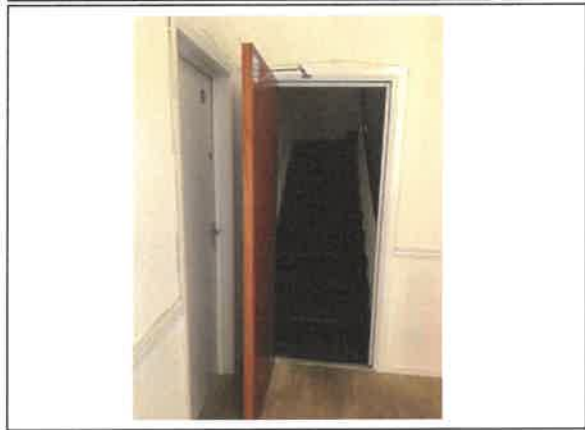
Fig 5: Ground floor lobby door not self-closing due to it sticking on the floor and also opens towards Flat 2 - door requires re-hanging so it opens away from Flat 2.

- Ground floor entrance lobby door sticking on the carpet and also opens towards Flat 2 restricting the escape of occupants from Flat 2 *(door closer requires adjusting and door requires re-hanging to open on the other side so as to not restrict evacuees from Flat 2).*

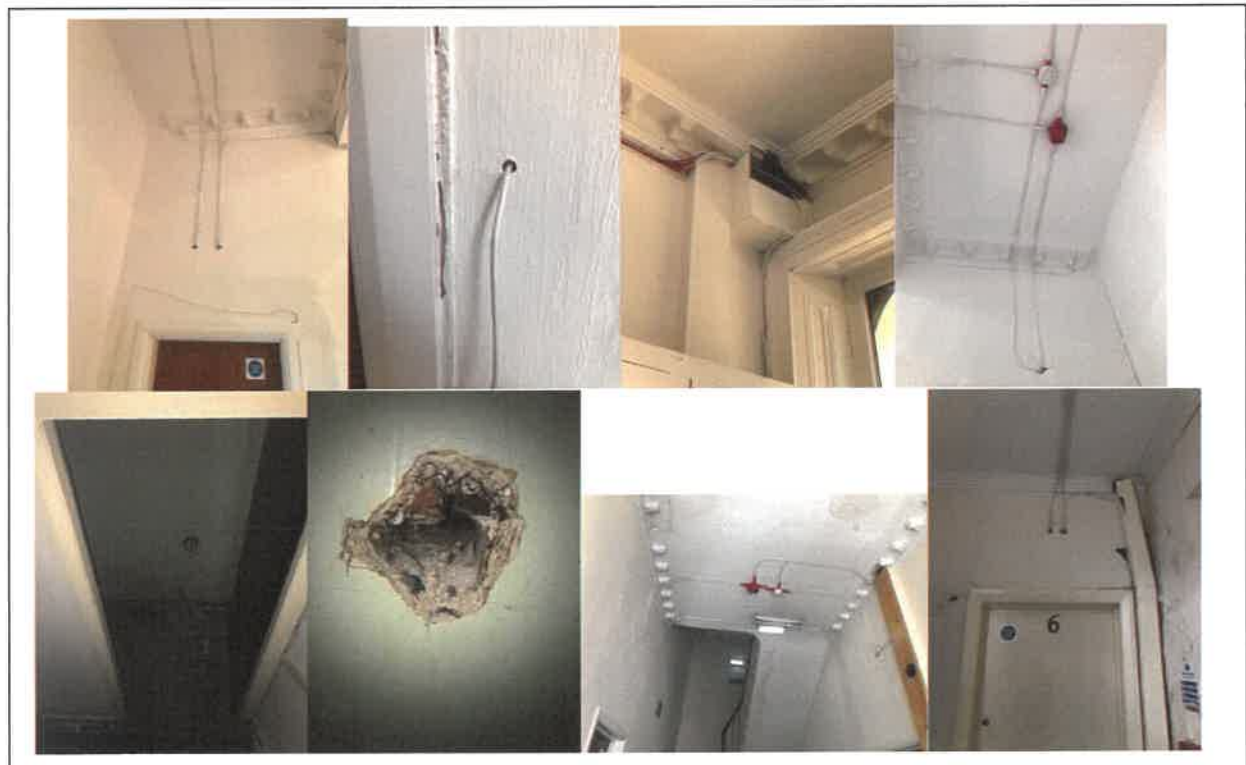
Fig 6: Fire stopping issues throughout where electrical / alarm cables have not been sealed at penetrations between floors and into flats. Further fire stopping issue noted in lower ground store at base of staircase.

<p>Minor issues with fire stopping noted where alarm cables which penetrate into the flats from the common areas have not been sealed.</p>	<p>Ensure a competent person using materials methods providing a minimum of thirty minutes fire resistance are used to seal all penetrations from alarm cabling from the common areas into flats.</p> <p>Note - The use of pink intumescent foam is not a one size fits all solution and care should be taken to ensure the correct product and method are used to provide thirty minutes fire resistance.</p>		
	<p>The underside of the section of flat roof, which forms part of the means of escape from the second floor external means of escape, could not be confirmed as providing a minimum of thirty minutes fire resistance.</p> <p>See Fig:7</p>	<p>Ensure the underside of the section of flat roof, which forms part of the means of escape from the second floor external means of escape, is fire stopped by a competent person using materials and methods providing a minimum of thirty minutes fire resistance.</p>

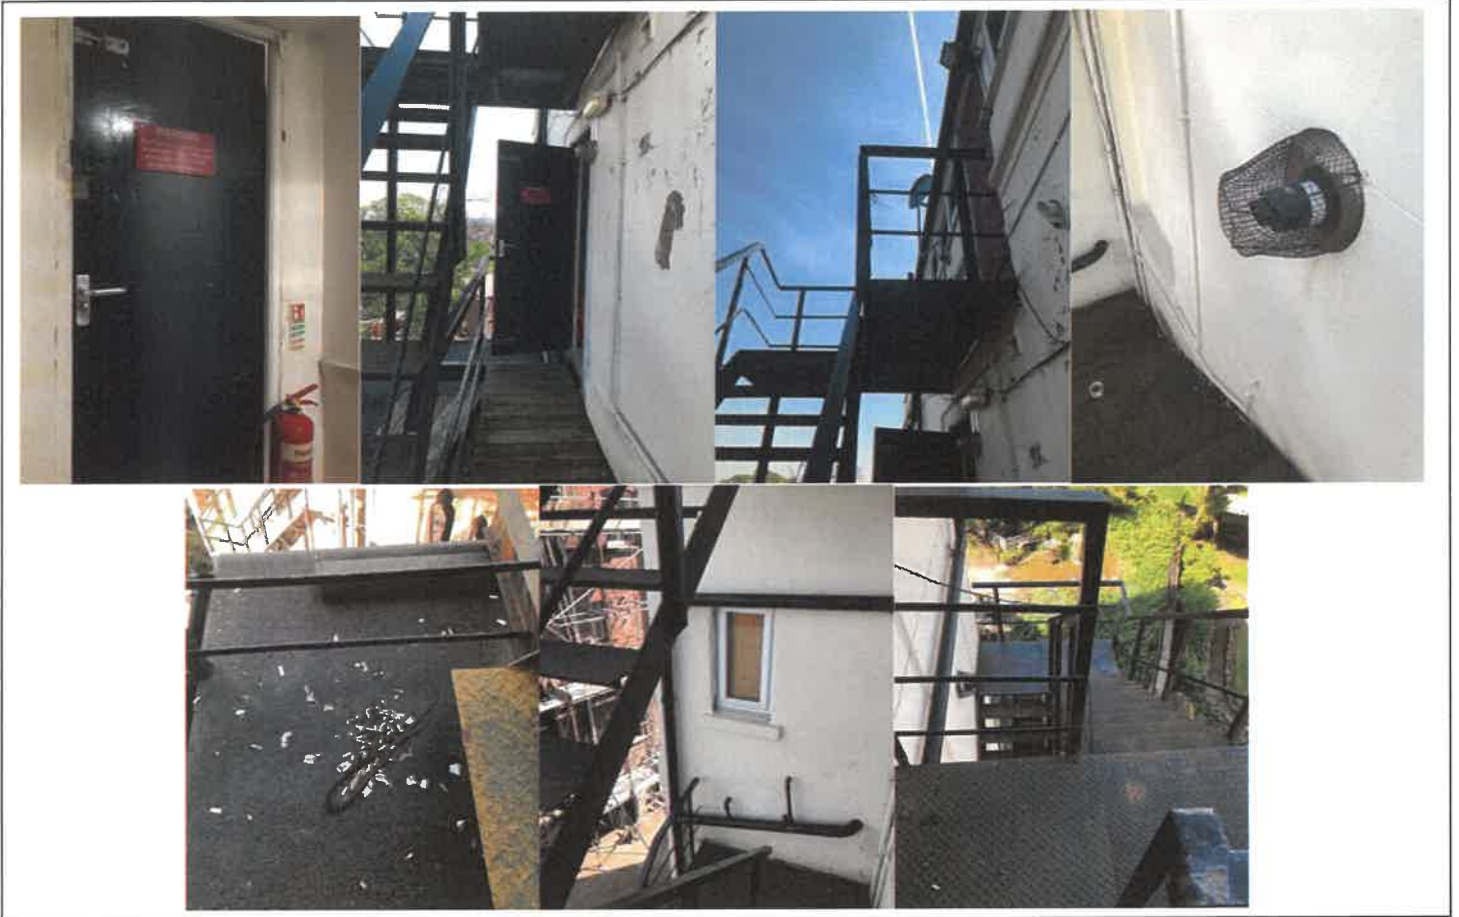
Fig 7: External escape route available from second floor landing and direct from third floor Flat 8. Issues noted relate to lack of fire resistant sealed shut windows, boiler flues within 1.8m of stair. Unable to confirm thirty minutes fire resistance of underside of flat roof section of external escape route and the presence of slide bolts to exit door from second floor.
