ASBESTOS SURVEY REPORT

REPORT ID NO.: *11/03/SYSV20*

SITE NAME: *Sayers*
241 Breck Road
Liverpool
L5 3LQ

This survey was undertaken by Mr P Roberts of Safety and Hygiene Consultants on 17th November 2003.

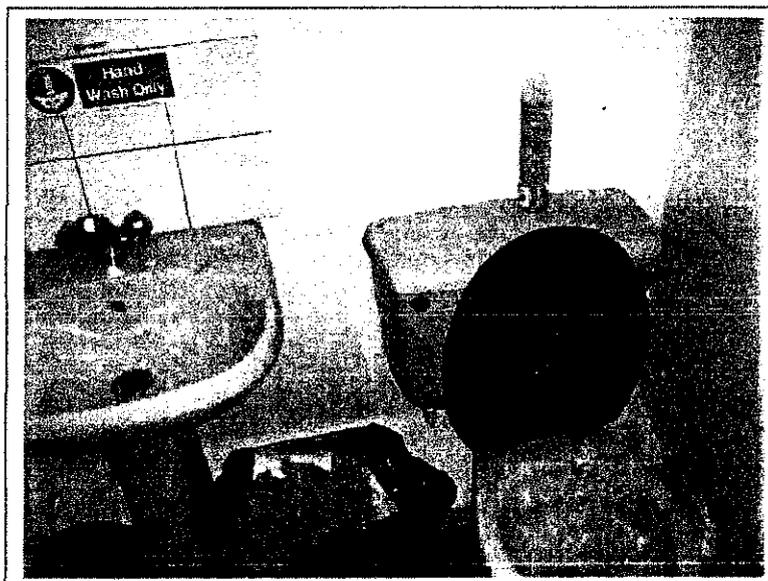
Air Movement/Position			Amount		
External (0) <input type="checkbox"/> Internal (1) <input type="checkbox"/> Induced vent (2) <input type="checkbox"/>			Small <input type="checkbox"/> Medium <input type="checkbox"/> Extensive <input type="checkbox"/>		
Friability			Exposed Population		
Low (0) <input type="checkbox"/> Medium (1) <input type="checkbox"/> High (4) <input type="checkbox"/>			Work Force <input type="checkbox"/> General Public <input type="checkbox"/> At Risk Groups <input type="checkbox"/>		
Accessibility			Risk Band		
Low (0) <input type="checkbox"/> Medium (1) <input type="checkbox"/> High (2) <input type="checkbox"/>			18 points or more (A) <input type="checkbox"/> 14-17 points (B) <input type="checkbox"/>		
			9-13 points (C) <input type="checkbox"/> 1-8 points (D) <input type="checkbox"/> 0 points (E) <input checked="" type="checkbox"/>

Remarks: Risk Band E.

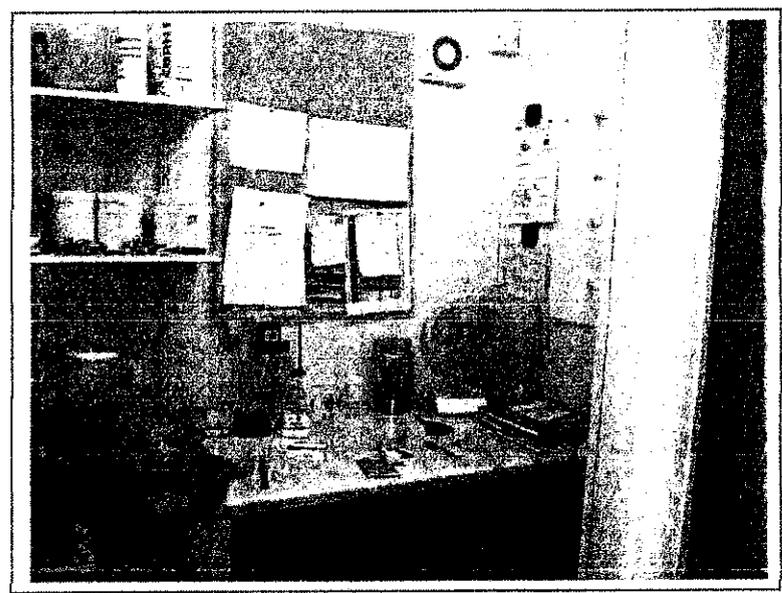
Site	Ground Floor, Staff Room	Sample Ref.	N/A
Location		Component

Remarks: For Information Only.

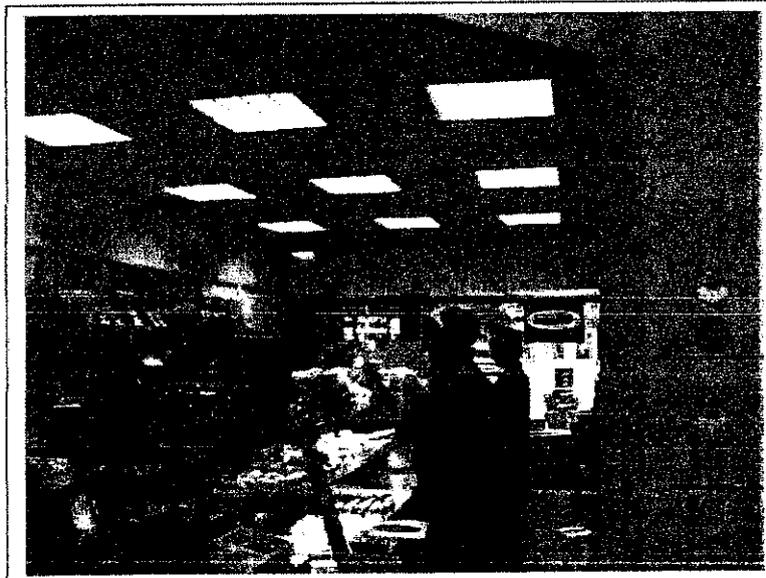
Air Movement/Position			Amount		
External (0) <input type="checkbox"/> Internal (1) <input type="checkbox"/> Induced vent (2) <input type="checkbox"/>			Small <input type="checkbox"/> Medium <input type="checkbox"/> Extensive <input type="checkbox"/>		
Friability			Exposed Population		
Low (0) <input type="checkbox"/> Medium (1) <input type="checkbox"/> High (4) <input type="checkbox"/>			Work Force <input type="checkbox"/> General Public <input type="checkbox"/> At Risk Groups <input type="checkbox"/>		
Accessibility			Risk Band		
Low (0) <input type="checkbox"/> Medium (1) <input type="checkbox"/> High (2) <input type="checkbox"/>			18 points or more (A) <input type="checkbox"/> 14-17 points (B) <input type="checkbox"/>		
			9-13 points (C) <input type="checkbox"/> 1-8 points (D) <input type="checkbox"/> 0 points (E) <input checked="" type="checkbox"/>

Remarks: Risk Band E.

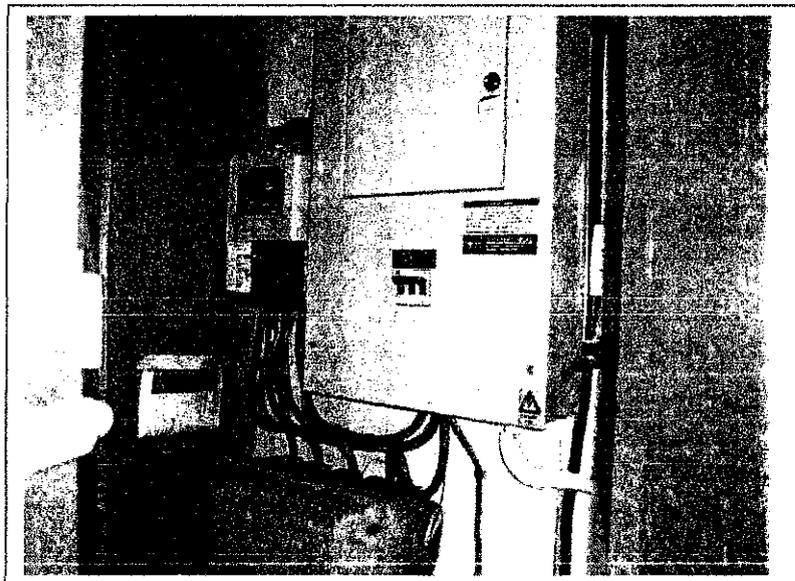
Site	Ground Floor, Electrical Cupboard	Sample Ref.	N/A
Location		Component

Remarks: For Information Only.

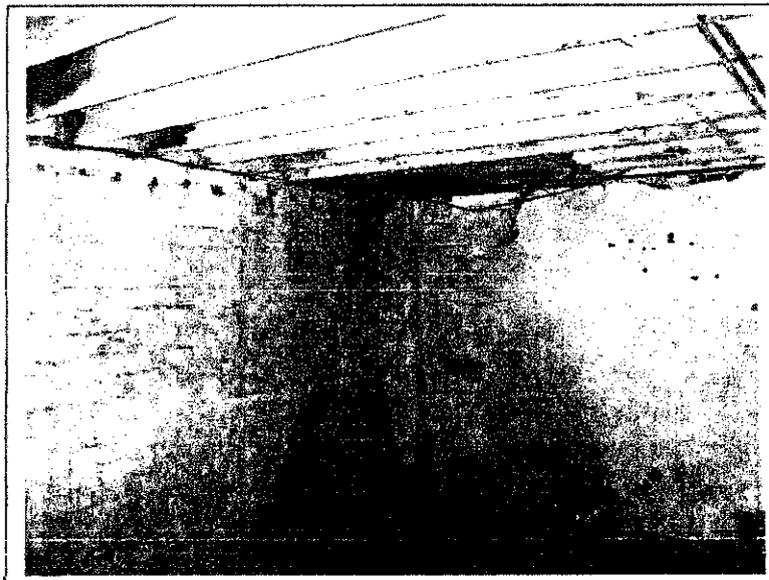
Client	Sayers	Sayers 241 Breck Road Liverpool L5 3LQ		Page	S13/12 of 14
---------------	--------	---	--	-------------	--------------

Remarks: For Information Only.

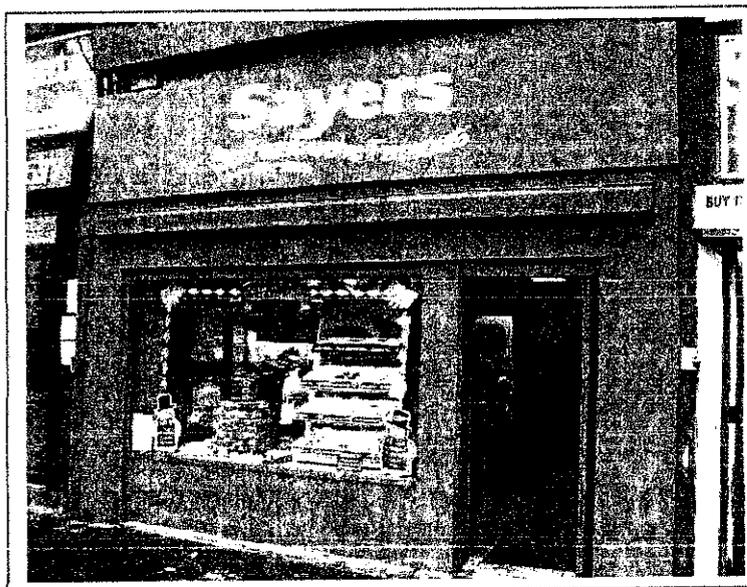
Remarks: For Information Only.
