Rec'd 6.6.19

16 Slatey Rd
13.5.19

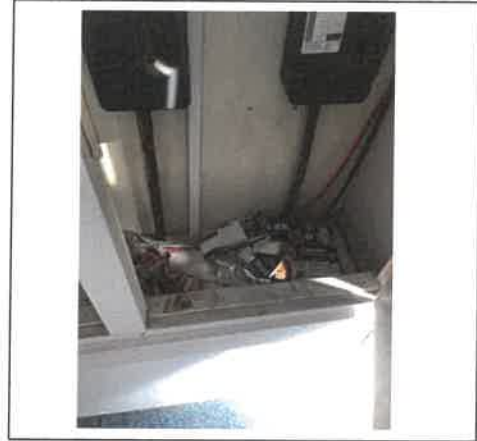
Fig 3: Unverified repairs to flat entrance doors where new locks have been fitted which in turn has compromised the integrity of the doors - recommended replacement of flat entrance doors with modern FD30s door sets

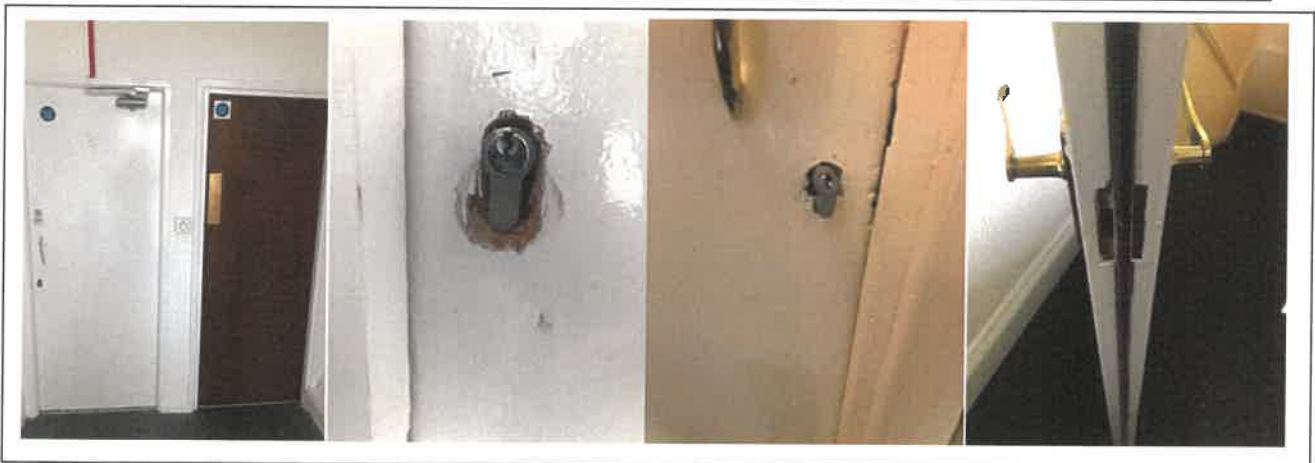
Fig 4: Heat detector at base of staircase to be replaced with smoke detector.

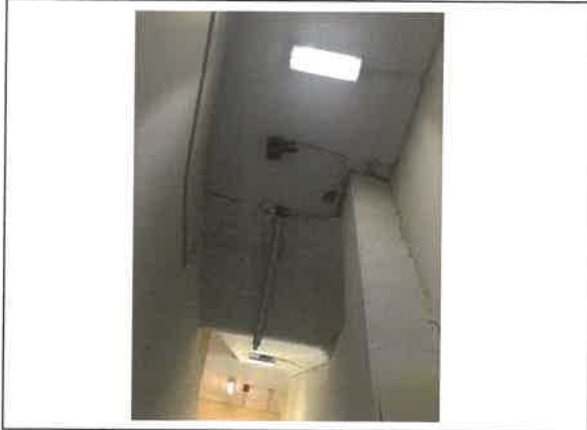
Fig 5: Boiler cupboards on first and second floor landing not suitably fire rated.

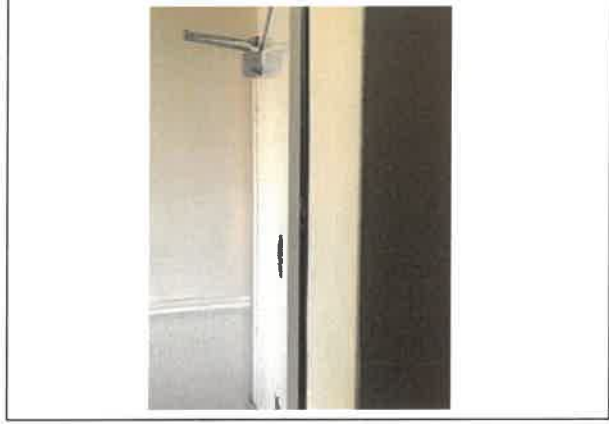
Fig 13: Covers missing from gas meters

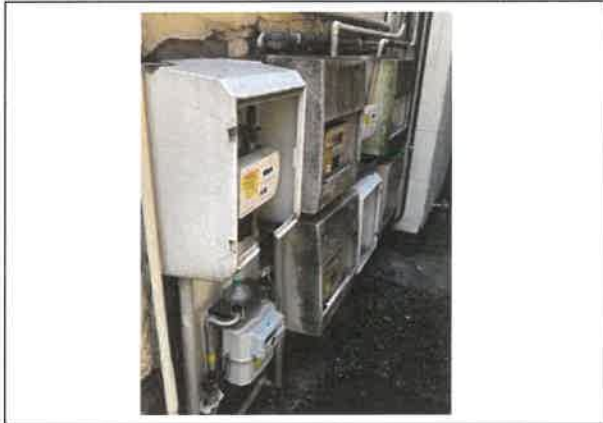
Fig 13: Unsecure waste bins.
